## An Actual FirstLook® Case History

## ACTUAL LIST OF PARTS AND JOBS PERFORMED BY OEM ON VEHICLE.

Automobile / 4 Door Sedan / 4 cylinder engine

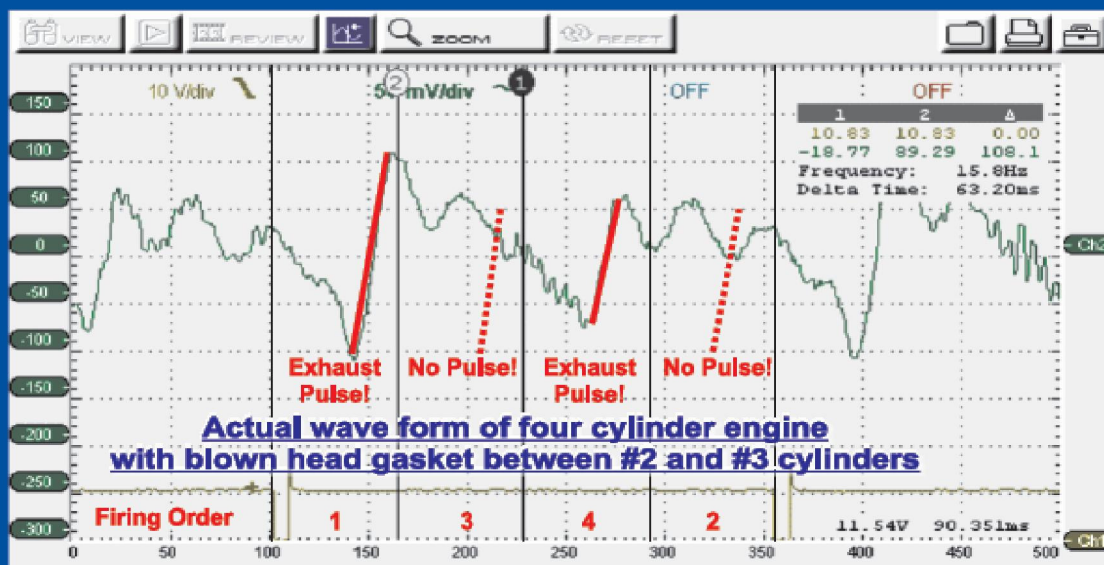
Cylinder 1 125 lbs 23% leak down, Cylinder 2 90 lbs 80% leak down

Cylinder 3 85 lbs 80% leak down, Cylinder 4 120 lbs 25% leak down

The following is a saved scope screen of what Jeff Kogan observed.

Cylinders #1 and #4 create strong pulses on their exhaust cycle. But adjacent cylinders #2 and #3 do not! A blown head gasket between these two cylinders is clearly indicated.

Checked valve clearance Cold, Spoke with person at Tech Line. Told head gasket starting to fail removed cylinder head. Replaced Head gasket RE assemble engine is running properly
